Government of the District of Columbia
Department of Transportation

Lighting Assessment Report

4th/Blair/Cedar NW Intersection and nearby areas Lighting Assessment

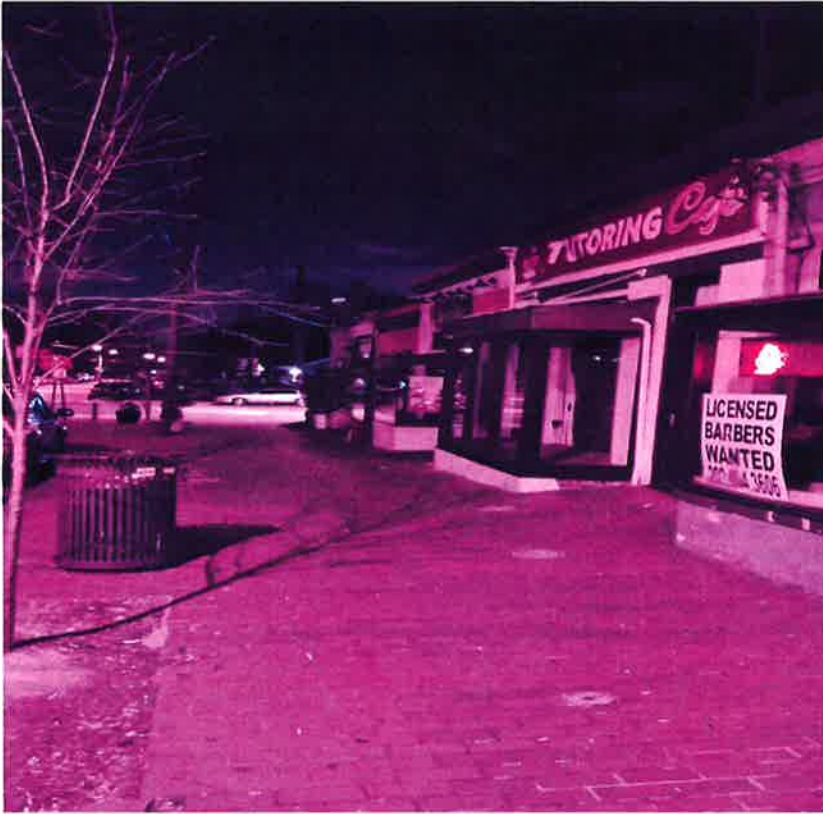
Photo 3. 4th Street between Butternut Street and Blair Road (West side sidewalk)

The average foot-candle values of the existing lighting conditions in the above street locations, comparing its values to the given parameters, in general are acceptable and for the most part exceed the recommended values. However, there are locations particularly sidewalks of 4th Street from Butternut to Blair Road (west side) and on Butternut from Blair Road to 4th Street (North side) that need lighting improvement. Dark areas are caused by uneven pole spacing, trees blocking light, or the luminaire is approaching end of life.

1. Convert existing streetlights to LED Teardrop fixture (Photo 1) in the following areas: 4th Street NW from Butternut Street to Blair Street; and Butternut Street from Blair Street to 4th Street NW. This work will be completed by September 15, 2017.
2. Replace existing streetlights that are approaching end of life with new lamps or fixtures. This work will be completed in 8-10 weeks.
3. Once 1 and 2 are completed, DDOT will reassess the lighting level of these locations and if found that it is not meeting the requirements, then DDOT will install supplemental lights on existing poles.
